Atlantic Mine stamp mill at Redridge, 1890's.

Atlantic Stamp Mill Operation

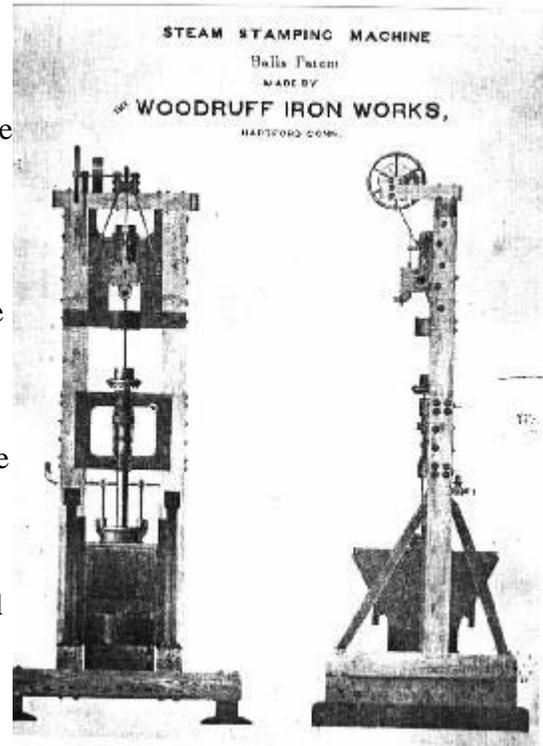
The Ball Stamp (circa 1875)

"Reynolds-Corliss" engine; one 14"x7"x12" "Garner" fire pump; 54 iron "Collum" jigs; one 50" "Prentice" drill press; one 18" "Prentice" lathe; one "Jarecki" pipe bolt and nut cutting machine; one "Daniels" planer, capacity 24"x24"x25"; jig countershafts for half the mill, complete, with couplings, pulleys and hangers, and the main line of steam pipe tapering from 14" in the boiler house to 6" at the far end of the mill.⁽⁵⁾ The boiler house that supplied power to the mill contained five 16'X6' "Evans" fire box boilers which were fired by cordwood. An interesting feature of the mill was the design of the smokestack, which can be seen in the illustration at the beginning of this chapter. Instead of going straight up off of the ground next to the boiler house, the stack (measuring 30' tall, 6' in diameter) was placed on the top of the bluff behind the mill, and a large smoke main 175' long, 7' in diameter was run up the hill to it. The reports do not state why this was done, but one theory would be that it was more cost effective than trying to raise a stack of similar height directly over the boiler house. The mill increased stamping capacity significantly, but it took quite a while for the company to take advantage of this due to inadequate hoisting capabilities back at the mine. At right is an illustration of the "Ball" Stamp used in the Atlantic Mill.

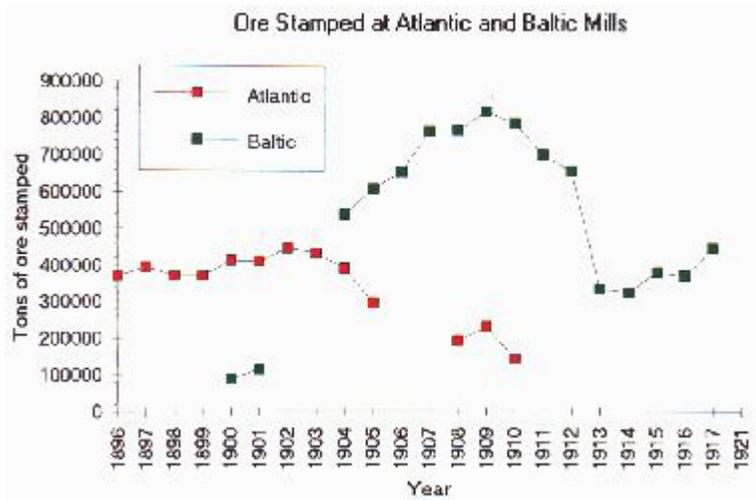
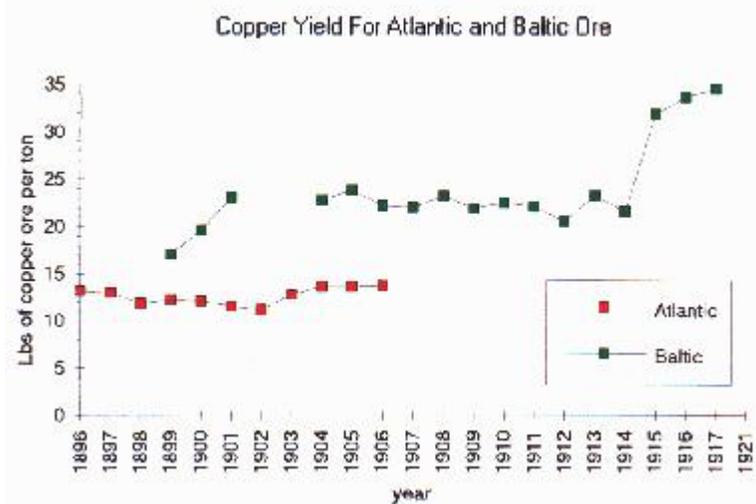
It may seem that the Atlantic mill had a short lifespan, but when one takes a look at the ore that it was given, it is a wonder that the company lasted as long as it did. The charts below illustrate the Atlantic's plight relative to the Baltic Mill.(14) The yield on the ore that Atlantic was bringing up was very poor in relation to most mines of the era. During the mill's lifetime, the yield on a ton of ore reached a high of only 13.69 pounds per ton for the year 1906, and a low of 11.095 pounds per ton in 1902, although there were some individual weeks where the yield would drop to as low as 6.54 pounds per ton.(15) The fact that this company was able to make a profit on such poor quality ore is a testament to efficient management.(16)

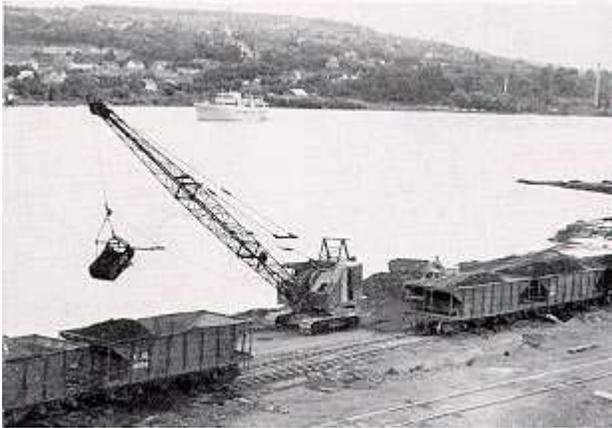
Shown here is the dragline hoisting stamp sands from the old Atlantic Mill site on Portage Lake to Copper Range Railroad cars for haulage to Freda Mill. In the background is the U.S. Park Service boat, Ranger III, on a trip to Isle Royale National Park.

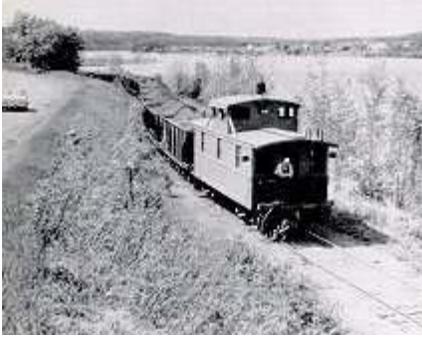
A trainload of Atlantic sands on their way to Freda Mill via the Copper Range Railroad. Conductor Harold Eilola sees where he's been from the platform, and Nels Swanson keeps track of the scenery from the caboose roof.

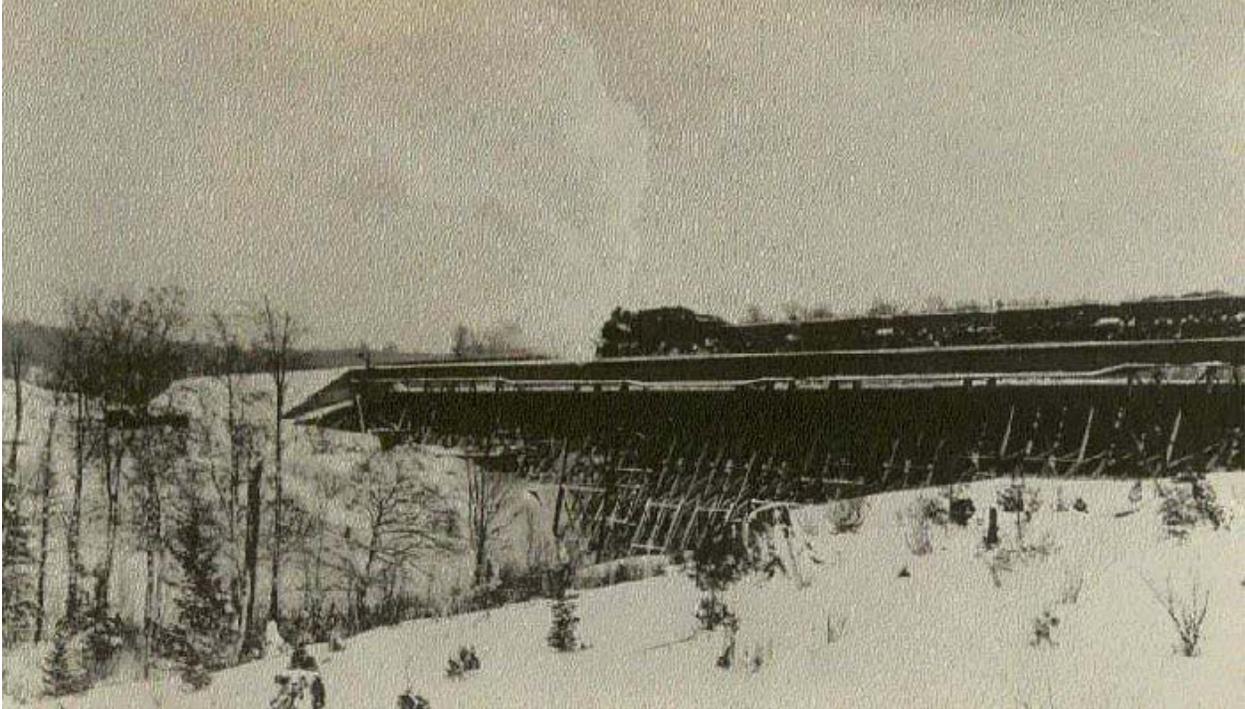
A rare photo of a Atlantic & Lake Superior RR rock train over the Redridge steel dam in the early 1900's.
